# Manhole Inspection Summary

Manhole # S51A\_\_014MH

Insp Date: **5/6/08 11:39 AM**

**Location** Address: **rear 219 n linwood ave**

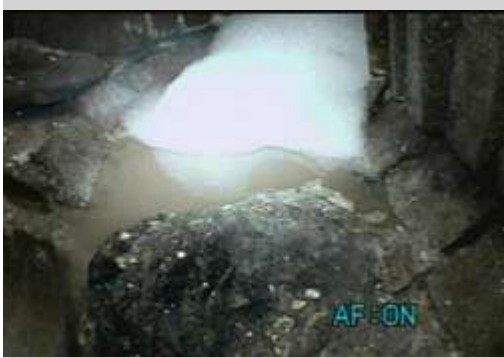
Defect 4

Condition: ☐ Sound ☐ Cracked ☐ Root Intrusion ☐ Deteriorated ☐ Leaks ☒ **Debris**

channel debris

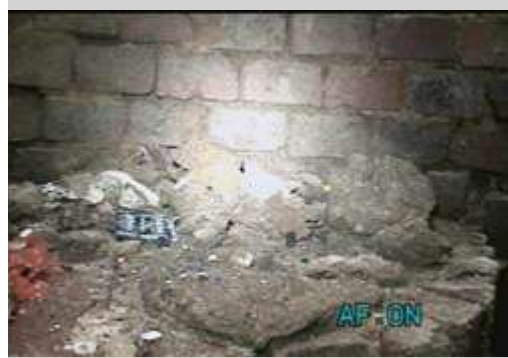
Defect 3

bench debris

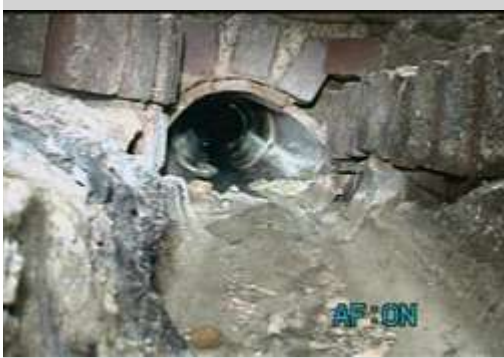
Defect 5

Condition: ☐ Sound ☒ **Cracked** ☐ Root Intrusion ☐ Deteriorated ☐ Leaks ☒ **Debris**

cracked channel

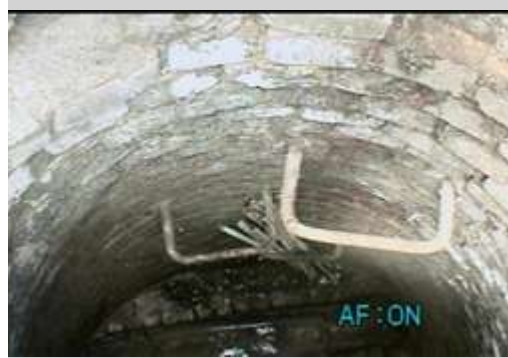
Defect 2

**Steps** Count: **3** Missing: **0** ☒ **Corroded**

steps

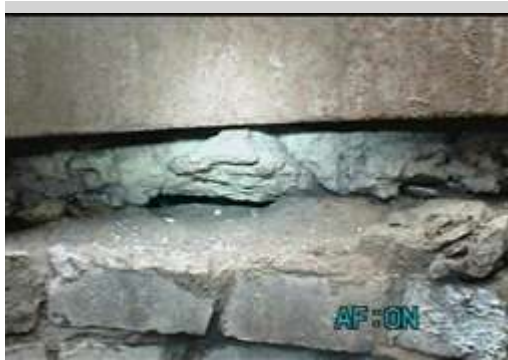
### Defect 1

Condition: ☐ Sound ☐ Cracked ☐ Root Intrusion ☐ Loose Brick ☒ **Deteriorated**

CHIMNEY\_COND\_DETERIORATED

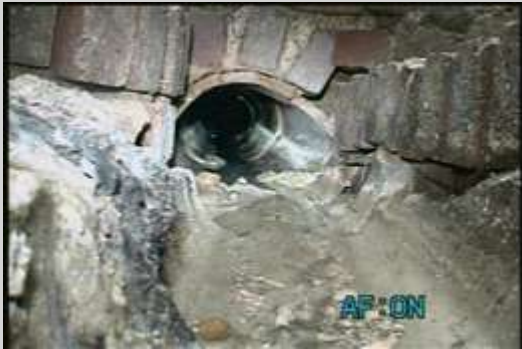
12 O'Clock Outflow

pipe at 12 & cracked channel

Deposits: ☐ None ☐ Mud ☐ Sludge ☒ **Debris** ☐ Grease

Silt Depth: **2** (in.) Deposits Extent: **Medium**
